Appendix M

Hale Avenue Resource Recovery Facility

Required Technical Investigation Order No. R9-2005-0077

The City of Escondido (the "City") hereby submits this report pursuant to San Diego Regional Water Quality Control Board ("SDRWQCB") Required Technical Investigation Order No. R9-2005-0077 regarding daily maximum effluent limitation exceedances that may have occurred between May 3 and June 27, 2004, from the Hale Avenue Resource Recovery Facility ("HARRF").

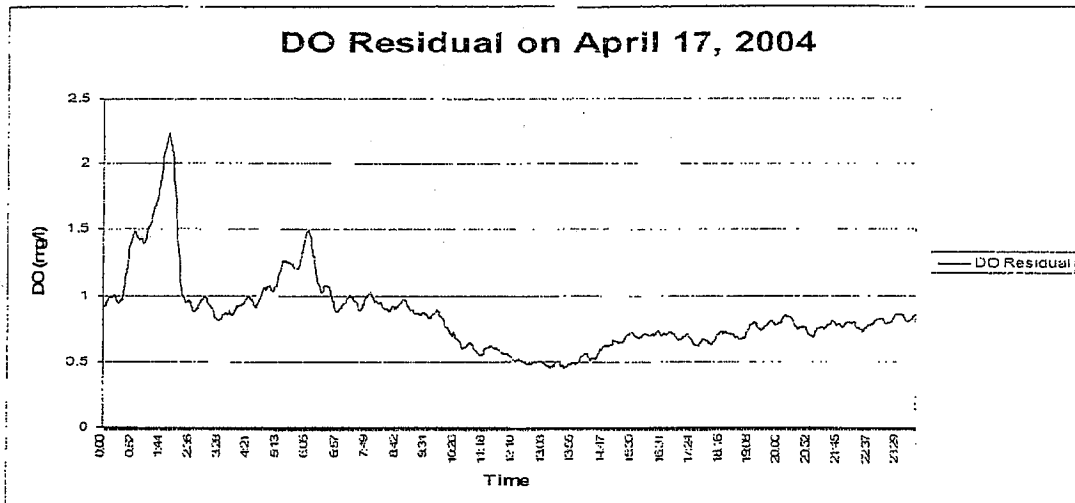
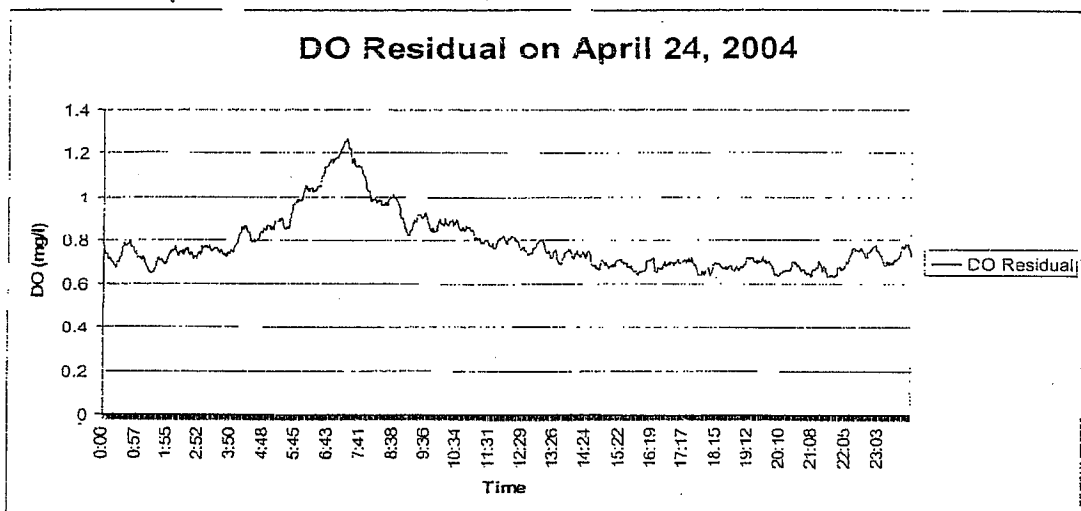
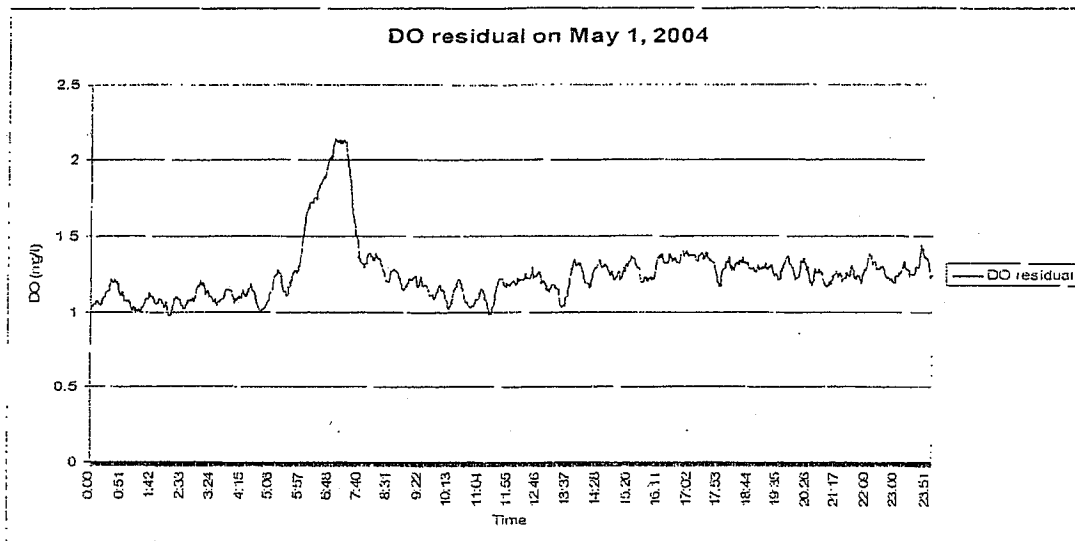
Figures 1-3. Daily Dissolved Oxygen Levels (Average of All Five Aeration Basins)

The treatment performance declined notably and in a similar fashion during the next three consecutive Saturdays. Specifically, sudden decreases in dissolved oxygen demand were noted in all five aeration basins beginning April 17, 2004 and continuing on each Saturday through May 1, 2004. Although the microorganism population began to recover after each weekend, the cumulative effect of these weekly disturbances was significant, and eventually the treatment process transitioned from aerobic to facultative and anaerobic. As a result of the change in microorganism population, secondary settling, turbidity and odors worsened.

This cyclic change in influent quality is not normal and indicates that something was being introduced into the collection system upstream from HARRF on a weekly basis, for example, as a result of a cleaning schedule for an industrial or commercial facility. The introduction of a toxin to the wastewater system can be seen by numerous indicators, including elevated levels of CBOD, TSS, odors, increased turbidity, acute toxicity in the secondary effluent and less activity noted in the microscopic examination of the activated sludge. These indicators were noted in the activated treatment process during the April 2004 disturbances. Toxic impacts on the biological treatment process can also be seen by increased levels of residual dissolved oxygen in the activated sludge (as described above) and poor CBOD removal in the secondary effluent. Indeed, as shown in Figures 1-3, there were unusually high spikes in the dissolved oxygen residual levels on April 17, 24, and May 1, consistent with short-term and intense hits by toxic materials from upstream of the facility. In addition, as shown in Figure 4, the cumulative effects of these impacts can be seen by the increasing average daily dissolved oxygen residual levels at the end of April 2004. This pattern is in marked contrast to the normal average daily dissolved oxygen level in any given month, as can be seen from the February 2004 average set

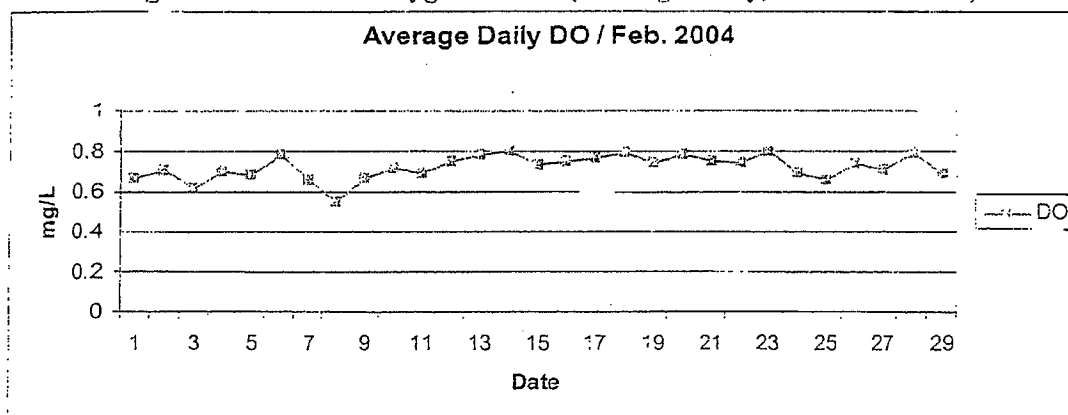
Figure 5. Dissolved Oxygen Levels (Average Daily, All Five Basins)

forth in Figure 5. There were no changes in HAARF's operational procedures, staffing, maintenance or equipment that would otherwise explain these treatment performance abnormalities.

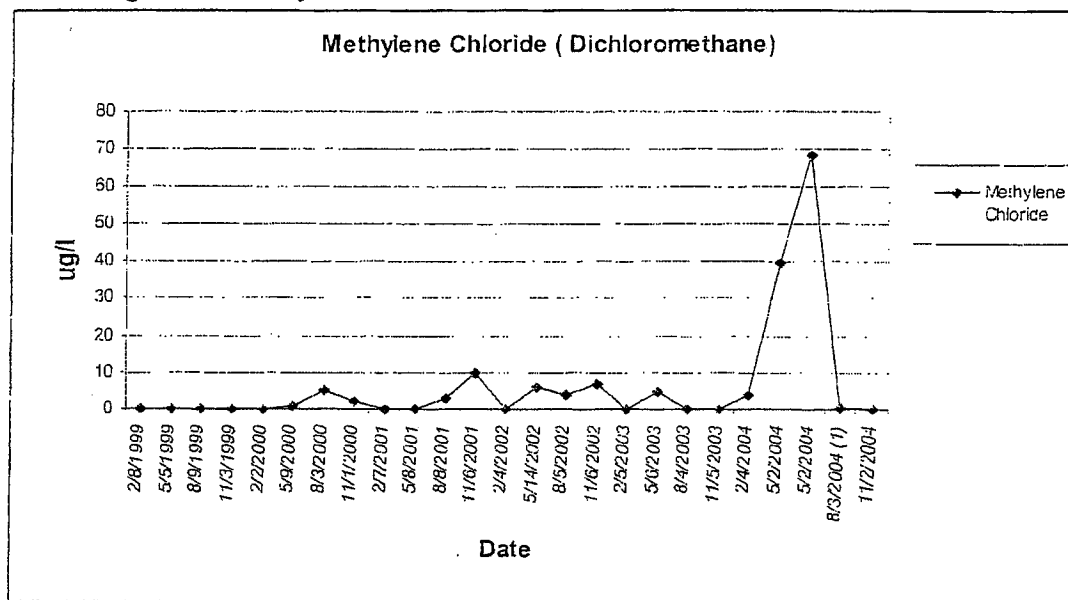
Figure 6. Methylene Chloride Levels in HARRF Influent 1999 to 2004

On May 2, 2004, an unusual and suspicious spike of methylene chloride (dichloromethane) was identified in the Escondido main sewer line. Monitoring results for this constituent from 1999 to 2004 are shown in Figure 6. The May 2004 sample is considerably higher than other recorded levels of methylene chloride (dichloromethane). Although the amount of methylene chloride (dichloromethane) that was found may not

have been responsible for the entire upset, it likely played a role in the disturbance of the previously weakened activated sludge process described above and prolonged the upset.

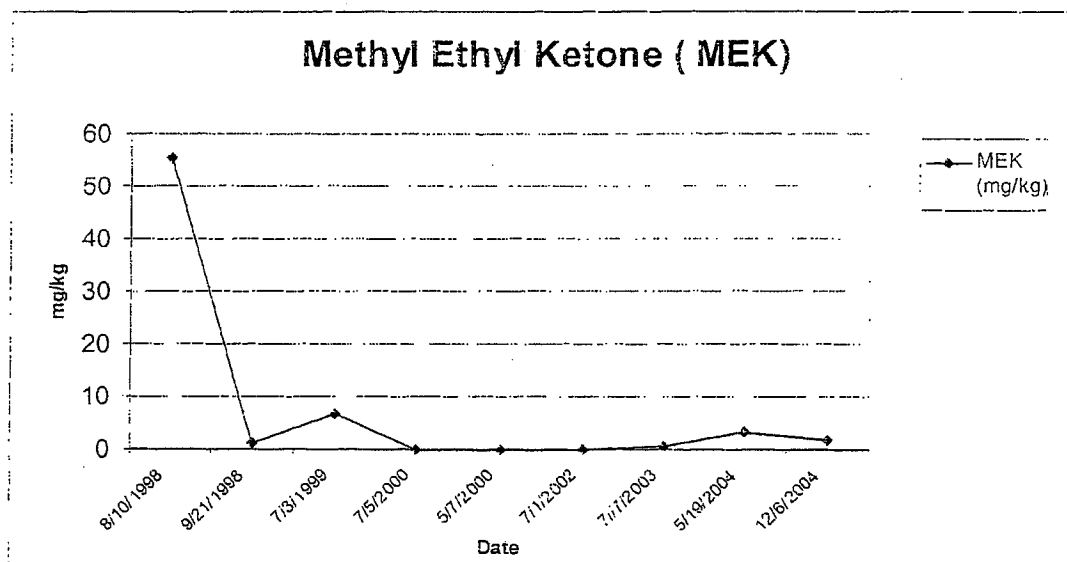
Figure 7. Methyl Ethyl Ketone Levels in HARRF Centrifuge Sludge Cake 1998 to 2004

On June 21-23, 2004, the sampling was expanded again to include another three lines (4937, 5105, and 4936). Results from these trunk lines showed high levels of toxic metals, TRPH and VOCs, including acetone. Results for the centrifuge sludge cake showed high levels of acetone and MEK. The levels of these constituents were higher than had been noted anytime within the past six years. MEK in the centrifugal sludge cake was 3200 micrograms per kilogram. In fact, the last time the MEK levels were found to be this high was during two previous plant upsets in 1998 and 1999. As noted in Figure 7, the spike in MEK in the influent was also higher than normal (although not as

high as in the sludge cake). Over the past six years, the spikes of MEK noted in the centrifuge sludge cake show a correlation with the treatment plant upsets in 1998, 1999 and 2004. MEK was identified as the cause of the 1998 incident, as well as the 1999 incident when similar levels of MEK were at issue.

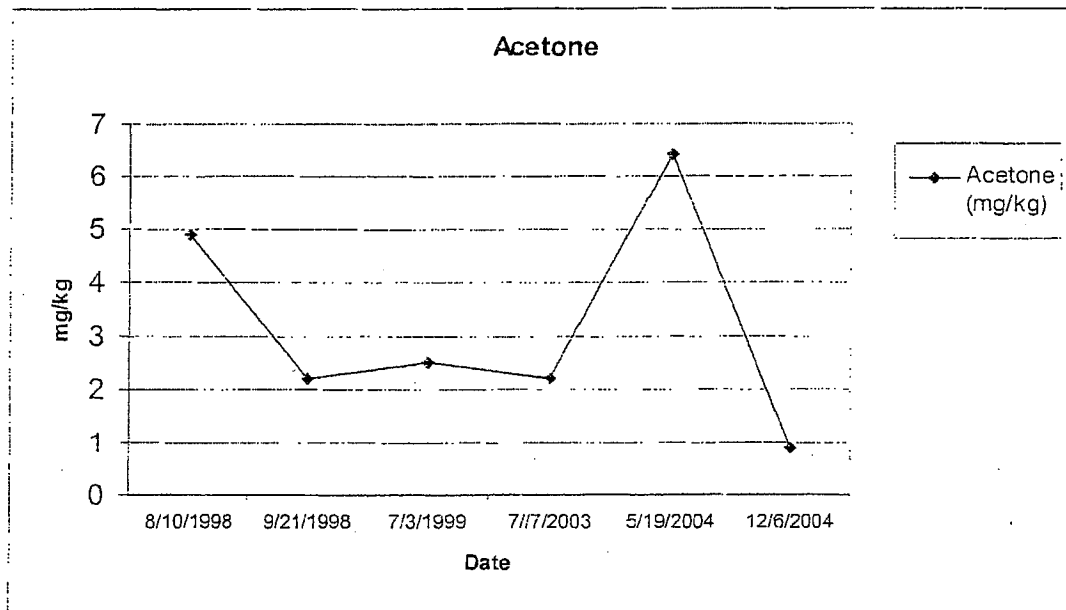
Figure 8. Acetone Levels in HARRF Centrifuge Sludge Cake 1998 to 2004

Acetone may also have had a role in negatively impacting the plant process because it was found at extremely high levels in the centrifuge sludge sample. These high levels are anomalous compared to sludge analyses in previous years as shown in Figure 8. The high acetone level in the sludge is also suspicious since the holding time for the sludge is approximately 25 days and much of the original levels in the influent would have been expected to degrade while traveling through the system.

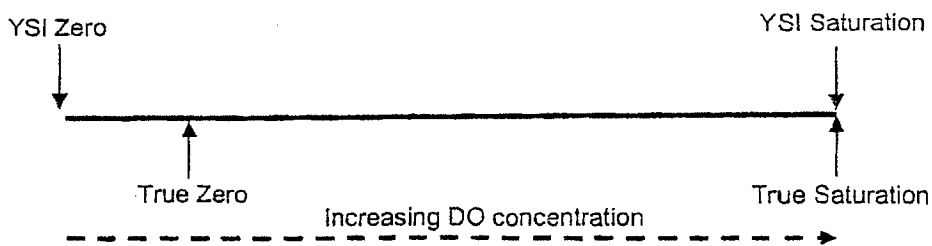
Figure 9

In July 2004, the City determined that the YSI Model 55 handheld unit was inaccurate at lower readings (zero saturation). Specifically, the handheld meter was registering levels of dissolved oxygen adequate for the treatment processes even though very little, if any, oxygen may have been present (see Figure 9). Thus, the City's weekly calibration of the handheld probe was inadequate because lower level readings can not be accurately determined in the YSI Model 55. If calibration inaccuracies had been occurring during the plant upset at the lower levels, the operators would have assumed that the dissolved oxygen levels in the basins at the lower levels were higher than the basin probes were indicating and adjusted the basin probes accordingly. Based on such inaccurate readings, the blower output would have been lowered. Such actions may inadvertently have resulted in further depriving the aerobic microbes of oxygen and prolonged the upset.

Figure 1 Relationship of YSI Model 55 DO probe readings to true DO readings

The YSI Model 55 handheld unit was replaced with HACH Model HQ10 LDO in July 2004, promptly after the YSI calibration problems were discovered. The replacement meter has demonstrated accuracy at a wider range of dissolved oxygen levels than the original, including at the lower levels up to and including zero oxygen levels. All the basin probes were replaced between April 29, 2004 and July 27, 2004. The replacement of the basin probes had been planned before the plant upset because the manufacturer no longer supports the equipment and it was difficult to obtain replacement parts.

Additionally, quality control procedures have been revised and implemented to include the laboratory checking the bench and handheld meters weekly using a titration method for dissolved oxygen. The laboratory will also run titrations on aeration basin samples weekly to verify the accuracy of the handheld unit and basin probes.

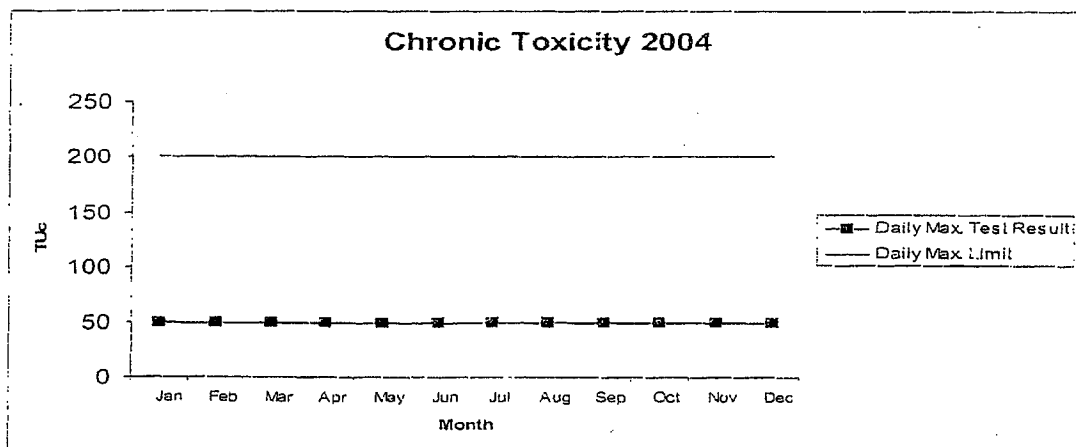
Figure 10. Chronic Toxicity in HARRF Effluent During 2004

In the monthly testing of secondary effluent, chronic toxicity was performed to evaluate the long term effects on the germination and growth of the most sensitive species of *Macrocystis pyrifera* (commonly known as Kelp). The May through August test results showed no effects on this species from HARRF discharges. Quarterly testing is also required to analyze toxic material for the protection of marine aquatic life. None of the toxic constituents were in violation of the daily maximum during May or August testing. Chronic toxicity testing results are shown in Figure 10. Tables showing the effluent limitations for toxic materials are located at the end of this Technical Report.

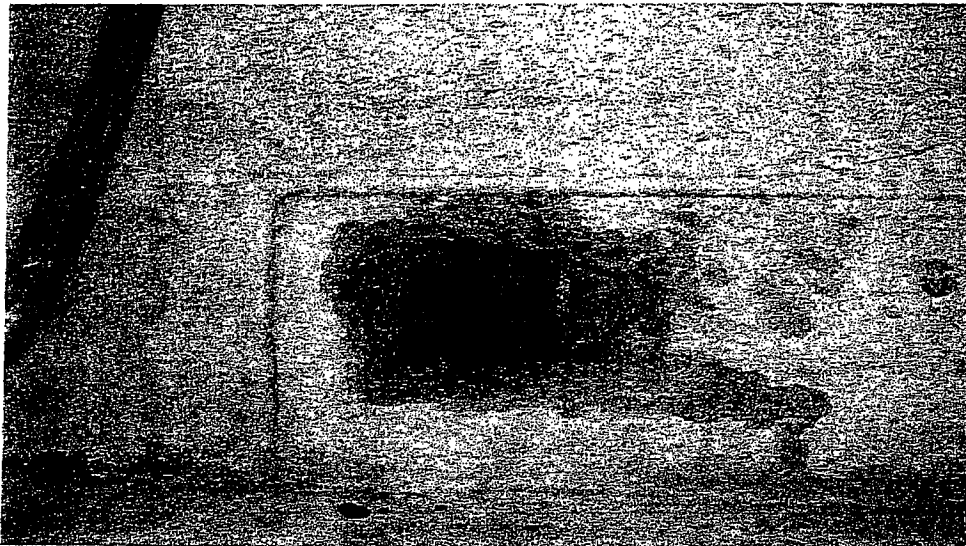
Attachment 5 Pictures of Iron Factory Illegal Connection

Factory, City staff discovered that there was an illegal sewer connection (a hole had been punched into the wall of their facility creating direct access to the sewer pipe) (see **Attachment 5**). The owner of the facility claimed that only the waste stream from their reverse osmosis process (brine water) had been discharged through this illegal connection.
